This MotoCAP safety rating applies to:

Brand: Ducati
Model: Giacca Tour V2
Type: Jacket - Textile
Date purchased: 11 August 2018
Sizes tested: XL
Gender: M & F
Style: Tourer
Test code: J18T03

Test Results Summary:

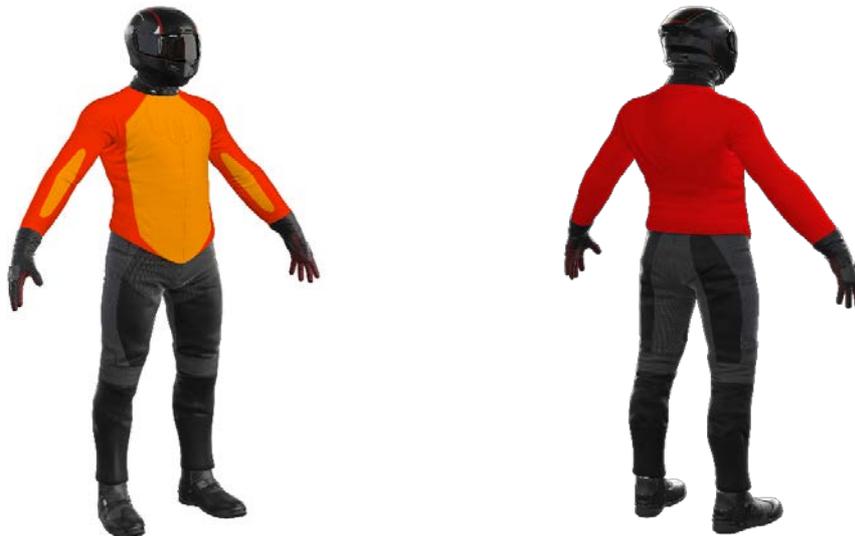
Zone	Coverage (%)	Abrasion time for each test (seconds)						Average (seconds)	
		1	2	3	4	5	6		
Zone 1 and 2 areas (High abrasion risk)									
Material A	100%	0.66	0.69	0.55	0.72	0.83	0.48	0.66	P
Zone 3 area (Medium abrasion risk)									
Material B	10%	0.82	0.49	0.58				0.63	P
Material A	90%	0.66	0.69	0.55	0.72	0.83	0.48	0.66	P
Zone 4 area (Low abrasion risk)									
Material A	100%	0.66	0.69	0.55	0.72	0.83	0.48	0.66	M

The diagram below is a visual indication of the likely abrasion performance of the materials in each zone calculated from the data in the table above. The colour coding is based on the worst performing material in each zone.

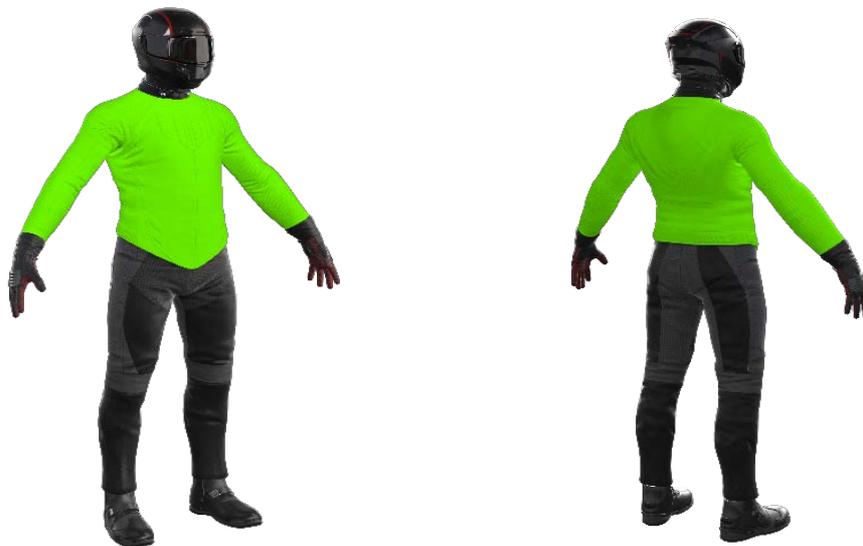
Area	1	2	3	4	5	Average	
Zones 1 & 2	1935	1493	1053	1758	913	1430	G
Zone EZ	1909	1204	1066	1189	929	1259	G
Zones 3 & 4	1322	994	1795	1141	1135	1277	G

The diagram below illustrates the burst strength results in terms of the likely performance of the garment in an impact and is a pictorial representation of the data from the table above.

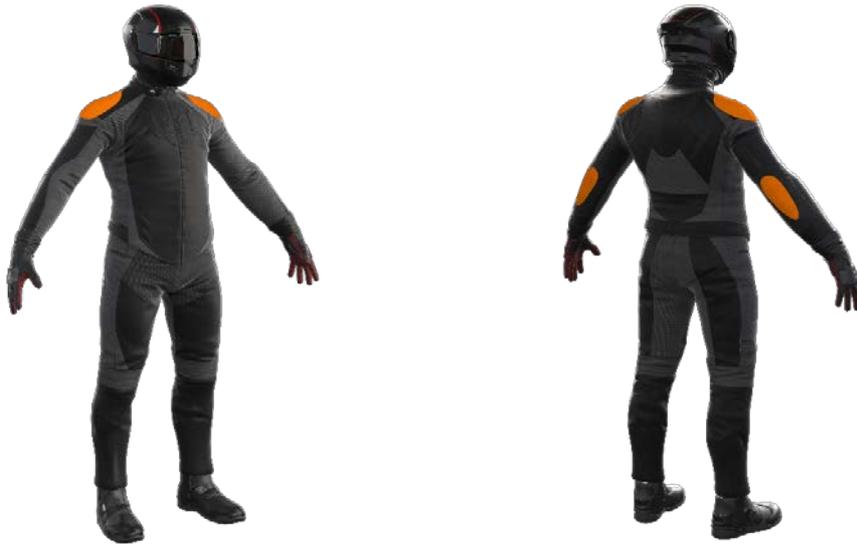
Impact protector type	Elbow		Shoulder	
Average force (kN)	24.4	A	23.0	A
Maximum force (kN)	28.3	M	27.5	M
Coverage of zone 1 area	150%		120%	
Coverage of zone after displacement	90%		120%

The diagram below is a visual indication of the likely impact performance of each impact protector calculated from the data in the table above. The colour coding is based on the worst score for force transmitted (average or maximum) in each impact zone.
