This MotoCAP safety rating applies to:

Brand: Harley Davidson

Model: Bentan Men's Riding Jacket

Sizes tested: XL
Gender: M
Style: Cruiser
Test code: J18T07

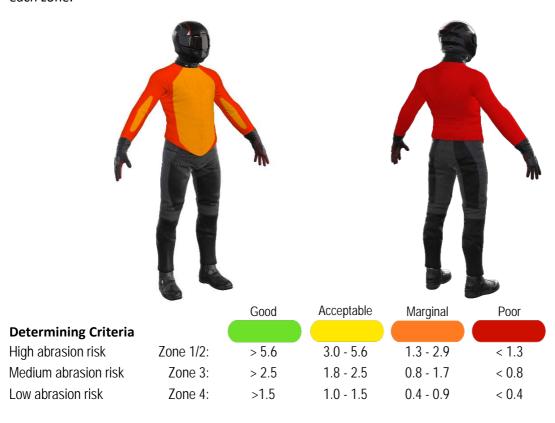
| Zone | Coverage | Abrasion time for each test (seconds) | | | | | Average | |
|---|---|---|---|---|---|---|---|---|
| Material A | 80% | 2.17 | 1.42 | 2.36 | 2.37 | 2.66 | 2.44 | 2.24 M |
| Material B | 20% | 0.21 | 0.31 | 0.64 | 0.46 | 0.53 | 0.58 | 0.45 P |
| Material C | 20% | 0.41 | 0.38 | 0.36 | 0.38 | 0.48 | 0.28 | 0.38 P |
| Material B | 90% | 0.21 | 0.31 | 0.64 | 0.46 | 0.53 | 0.58 | 0.45 M |

The diagram below is a visual indication of the likely abrasion performance of the materials in each zone calculated from the data in the table above. The colour coding is based on the worst performing material in each zone.

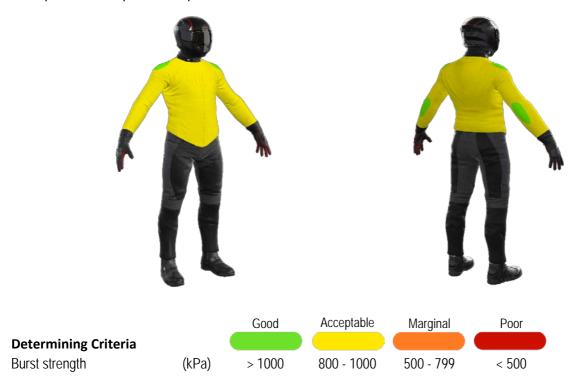
| Area | 1 | 2 | 3 | 4 | 5 | Average |
|---|---|---|---|---|---|---|
| Zones 1 & 2 | 958 | 1442 | 1120 | 868 | 1161 | 1110 G |
| Zone EZ | 860 | 1004 | 643 | 910 | 763 | 836 A |
| Zones 3 & 4 | 867 | 1254 | 852 | 764 | 687 | 885 A |

The diagram below illustrates the burst strength results in terms of the likely performance of the garment in an impact and is a pictorial representation of the data from the table above.

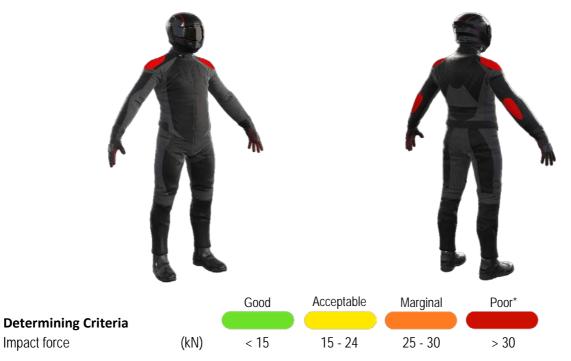
The diagram below is a visual indication of the likely impact performance of each impact protector calculated from the data in the table above. The colour coding is based on the worst score for force transmitted (average or maximum) in each impact zone.

^{*} Poor may also indicate that no impact protector, or impact protector pocket is present in the garment

An impact force of 50.0kN was used in all impact force calculations for this garment as impact protectors were not present. The garment achieved a 1/10 rating for impact protection as pockets were present to allow the use of aftermarket elbow and shoulder impact protectors
