### This MotoCAP safety rating applies to:

Brand: Rjays Model: Dune

Type: Jacket - Textile

Sizes tested: XXL
Gender: M & F
Style: Tourer
Test code: J18T08

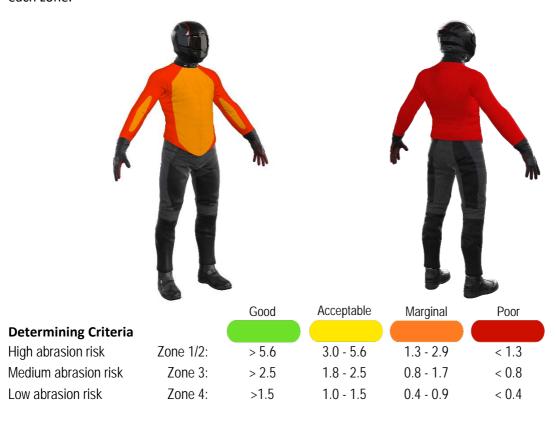
Zone	Coverage	Abrasion time for each test (seconds)					Average	
	(%)	1	2	3	4	5	6	(seconds)
Zone 1 and 2	areas (High abra	ision risk)						
Material A	30%	2.74	2.18	2.32	2.35	2.01	2.36	2.33 M
Material B	70%	0.32	0.47	0.35	0.66	0.48	0.38	0.44 P
Zone 3 area (N	Medium abrasion	n risk)						
Material C	20%	4.96	7.28	5.78	3.97	3.18	3.75	4.82 <b>G</b>
Material B	80%	0.32	0.47	0.35	0.66	0.48	0.38	0.44 P
Zone 4 area (Low abrasion risk)								
Material B	100%	0.32	0.47	0.35	0.66	0.48	0.38	0.44 M

The diagram below is a visual indication of the likely abrasion performance of the materials in each zone calculated from the data in the table above. The colour coding is based on the worst performing material in each zone.

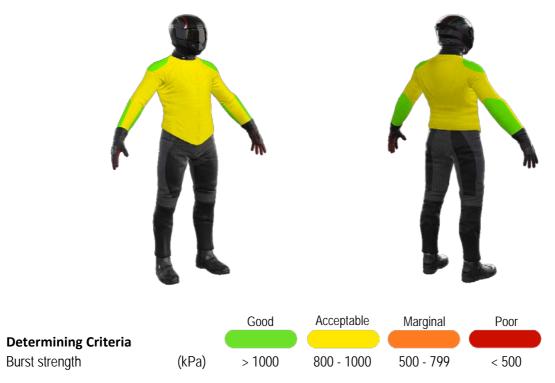
Area	1	2	3	4	5	Average	
Zones 1 & 2	1496	1506	1579	859	1206	1329	G
Zone EZ	1509	1057	1204	691	1096	1111	G
Zones 3 & 4	768	768	924	742	912	823	Α

The diagram below illustrates the burst strength results in terms of the likely performance of the garment in an impact and is a pictorial representation of the data from the table above.

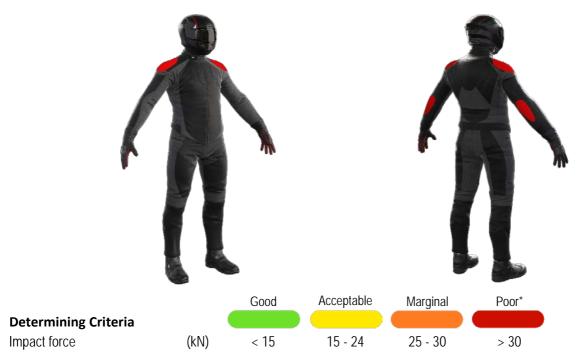
Impact force (kN)	Elbow			Shoulder		
Strike location	Α	В	С	Α	В	С
Impact Protector 1	14.7	18.4	31.3	18.6	24.1	27.1
Impact Protector 2	17.2	23.8	28.1	12.9	16.3	26.4
Impact Protector 3	13.8	20.3	26.1	23.4	20.3	30.3

The diagram below is a visual indication of the likely impact performance of each impact protector calculated from the data in the table above. The colour coding is based on the worst score for force transmitted (average or maximum) in each impact zone.

<sup>\*</sup> Poor may also indicate that no impact protector, or impact protector pocket is present in the garment
