This MotoCAP safety rating applies to:

Brand: Rev'It Model: Horizon 2 Type: Jacket - Textile Date purchased: 19 March 2019 Sizes tested: L and 2XL Gender: M & F Style: Tourer Test code: J19T11

Test Results Summary:

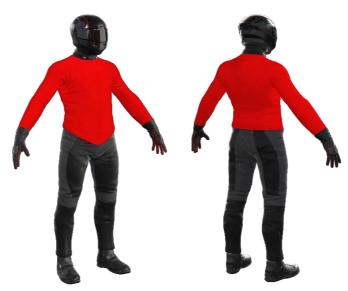
Zone	Coverage	Abrasion t	time for eac	ch test (sec	conds)			Average
	(%)	1	2	3	4	5	6	(seconds)
Zone 1 and 2	areas (High abra	asion risk)						
Material A	100%	0.63	0.65	0.74	0.78	0.60	0.74	0.69 P
Zone 3 area (Medium abrasio	n risk)						
Material A	25%	0.63	0.65	0.74	0.78	0.60	0.74	0.69 P
Material B	75%	0.35	0.27	0.35	0.34	0.30	0.43	0.34 P
Zone 4 area (Low abrasion ris	k)						
Material A	15%	0.63	0.65	0.74	0.78	0.60	0.74	0.69 M
Material B	85%	0.35	0.27	0.35	0.34	0.30	0.43	0.34 P

The diagram below is a visual indication of the likely abrasion performance of the materials in each zone calculated from the data in the table above. The colour coding is based on the worst performing material in each zone.

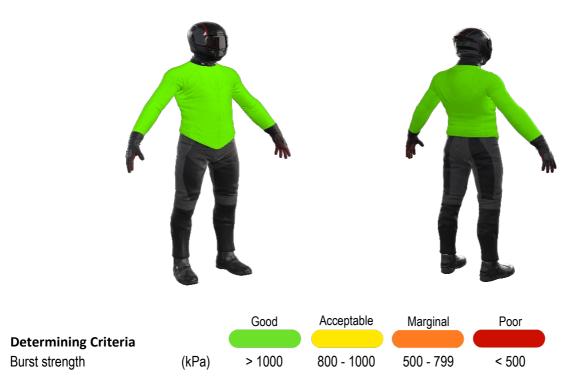
Area	1	2	3	4	5	Average
Zones 1 & 2	1218	1078	1436	793	1518	1208 G
Zone EZ	1429	1621	1239	1289	1124	1340 G
Zones 3 & 4	1038	1064	1105	1123	859	1038 G

The diagram below illustrates the burst strength results in terms of the likely performance of the garment in an impact and is a pictorial representation of the data from the table above.

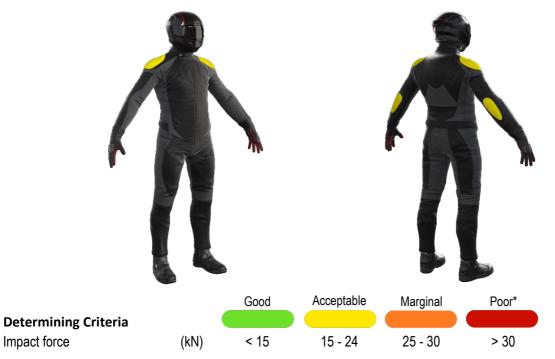
Impact protector type	Elbow		Shoulder
Average force (kN)	18.9	A	18.5 A
Maximum force (kN)	19.5	Α	19.0 A
Coverage of zone 1 area	150%		110%
Coverage of zone after displacement	100%		100%

The diagram below is a visual indication of the likely performance of each impact protector calculated from the data in the table above. The colour coding is based on the worst performing score for average or maximium force for each impact zone.
