**This MotoCAP safety rating applies to:**

<b>Brand:</b>	DriRider
<b>Model:</b>	Nordic 3 Airflow
<b>Type:</b>	Jacket - Textile
<b>Date purchased:</b>	11 February 2019
<b>Sizes tested:</b>	L and XL
<b>Gender:</b>	M
<b>Style:</b>	Tourer
<b>Test code:</b>	J19T07

**Test Results Summary:**

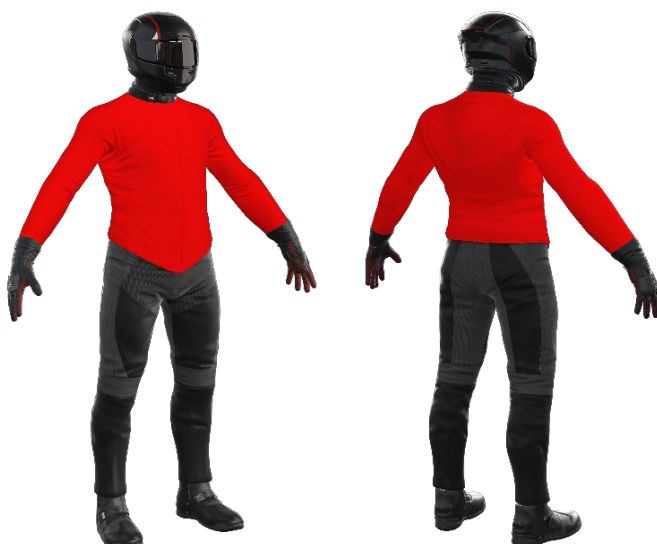
Zone	Coverage (%)	Abrasion time for each test (seconds)						Average (seconds)	
		1	2	3	4	5	6		
Zone 1 and 2 areas (High abrasion risk)									
Material A	90%	3.11	2.75	2.23	2.43	3.43	3.49	2.91	M
Material B	10%	0.56	0.30	0.14	0.18	0.53	0.70	0.40	P
Zone 3 area (Medium abrasion risk)									
Material C	80%	0.36	0.37	0.24	0.16	0.21	0.20	0.26	P
Material B	20%	0.56	0.30	0.14	0.18	0.53	0.70	0.40	P
Zone 4 area (Low abrasion risk)									
Material C	70%	0.36	0.37	0.24	0.16	0.21	0.20	0.26	P
Material B	30%	0.56	0.30	0.14	0.18	0.53	0.70	0.40	M

The diagram below is a visual indication of the likely abrasion performance of the materials in each zone calculated from the data in the table above. The colour coding is based on the worst performing material in each zone.

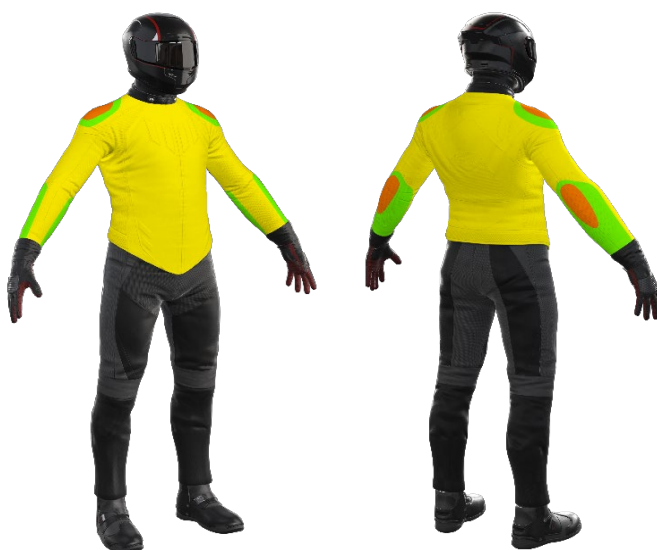
Area	1	2	3	4	5	Average	
Zones 1 & 2	812	604	604	759	588	674	M
Zone EZ	1260	1730	1575	964	1386	1383	G
Zones 3 & 4	890	693	1254	713	723	855	A

The diagram below illustrates the burst strength results in terms of the likely performance of the garment in an impact and is a pictorial representation of the data from the table above.

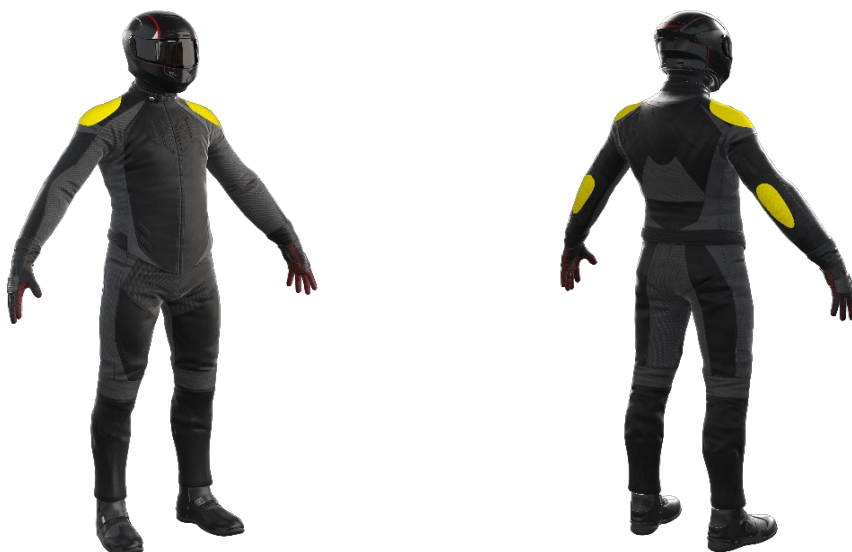
Impact protector type	Elbow		Shoulder	
Average force (kN)	19.7	A	20.3	A
Maximum force (kN)	20.4	A	20.9	A
Coverage of zone 1 area	95%		95%	
Coverage of zone after displacement	80%		95%

The diagram below is a visual indication of the likely performance of each impact protector calculated from the data in the table above. The colour coding is based on the worst performing score for average or maximum force for each impact zone.
